ERRATA

January 6, 2025

K24 Development Kit – Revision 1

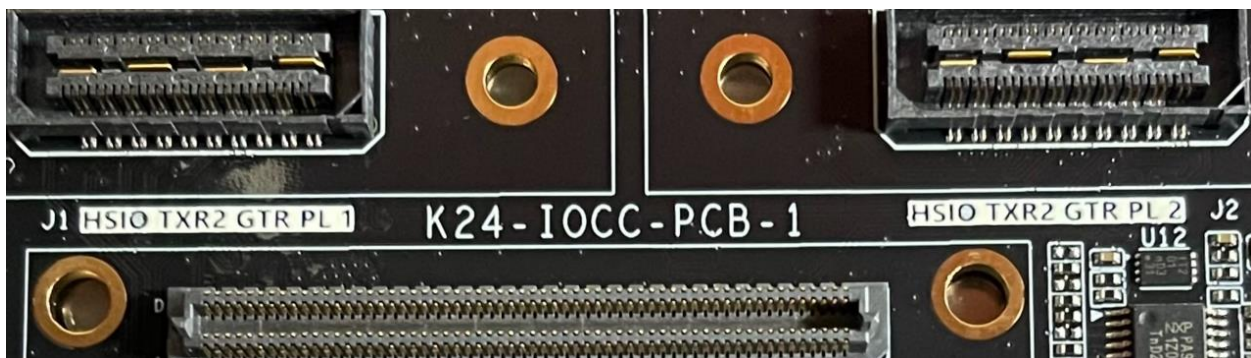
Board Top Side View

The K24 Development Kits affected by these errata can be identified by the PCB Revision listed in silkscreen on the top of the K24 IO Carrier Card PCB. The PCB Revision of the K24 IO Carrier Card is listed in silkscreen and can be found on the top side of the board between the HSIO connectors and the topmost connector of the K24 System-On-Module. The current production revision is “K24-IOCC-PCB-1”. Boards that are at this production revision are affected.

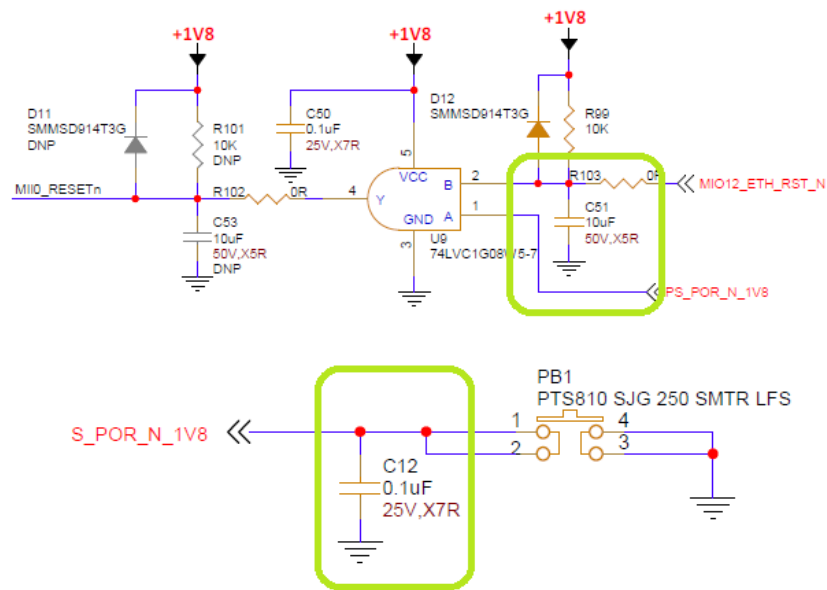
Capacitors to Remove

Description – There appears to be a reliability issue with the Ethernet during reset. In the cases where the Ethernet reliability issue occurs, software may not properly detect the Ethernet PHY.

Workaround – To overcome the reliability issues with Ethernet, there are a couple of recommendations. First, it has been found that removing capacitors C12 and C51 from the K24 IO Carrier Card yielded a more reliable Ethernet reset signal.

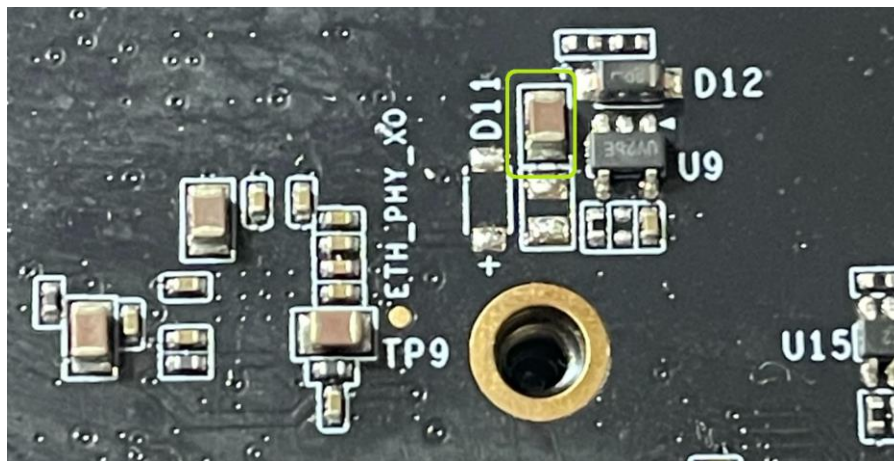
C51 Location on Board Bottom Side – Green Box

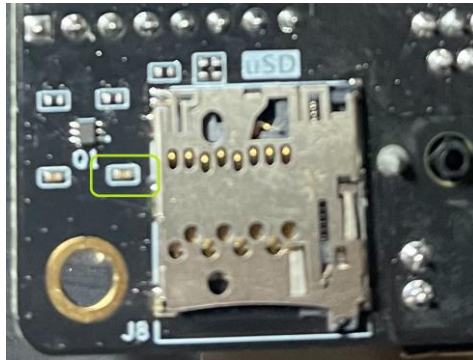
C12 Location on Board Bottom Side – Green Box

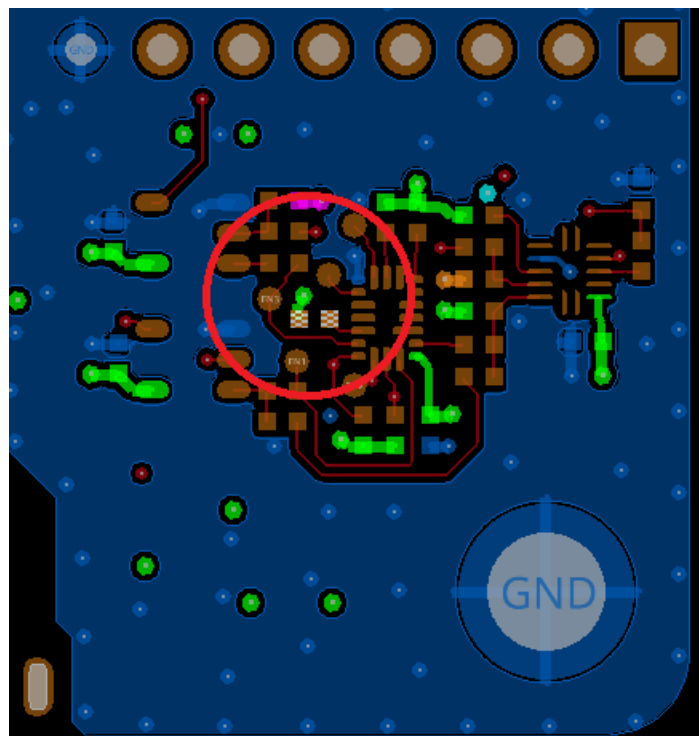
Description – There is an issue with the implementation of the on/off sequencer U22 (SLG7TD43741VTR) that prevents the board from completing it's power down sequence following the long depress of push button PB7. This failure mode is indicated by the PG LED D26 remaining illuminated no matter how long push button PB7 is depressed.

R334 Location on Board Bottom Side – Red Circle

Physical Workaround - To get the proper power down functionality, resistor R334 needs to be removed and a wire needs to be added from TP44 (EN3) to R334 signal pad. In essence this shorts EN3 to PG3 on U22.

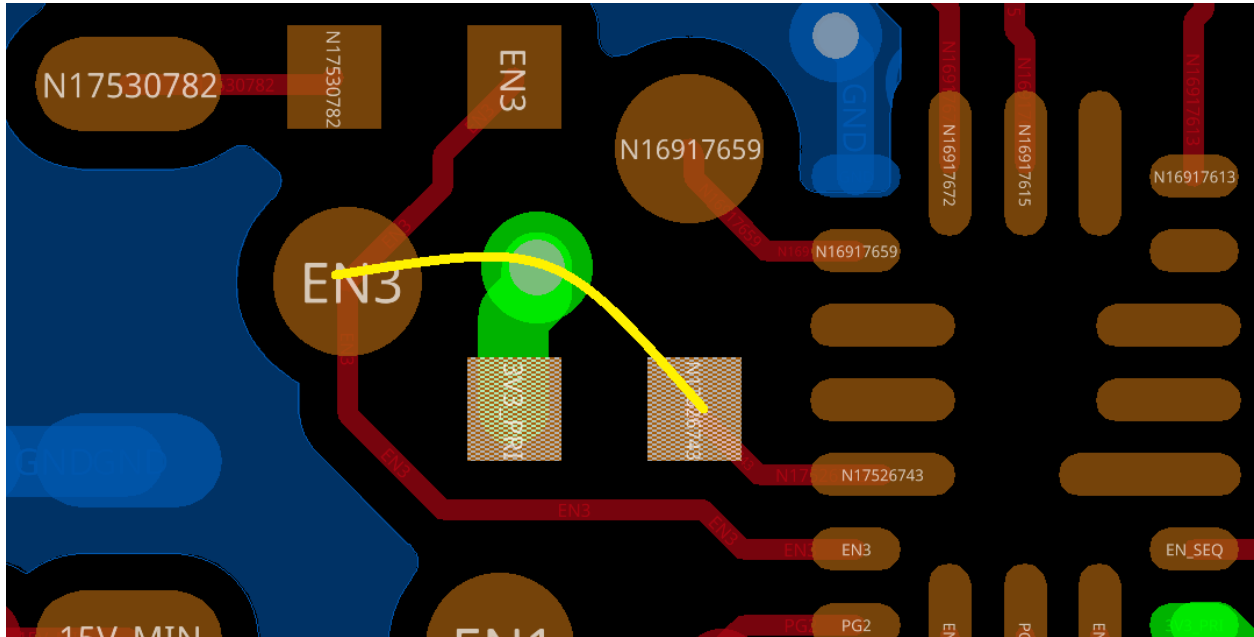
Wire from TP44 (EN3 Test point) and R334 Signal Pad on Board Bottom Side – Yellow Line
